6 PROCEEDINGS OF THE 1980 TRI-SERVICE
CONFERENCE ON CORROSION

5-7 NOVEMBER 1980
US AIR FORCE ACADEMY, COLORADO, Volume I.

CORROSION OF NAVAL SEA SYSTEMS
AN OVERVIEW

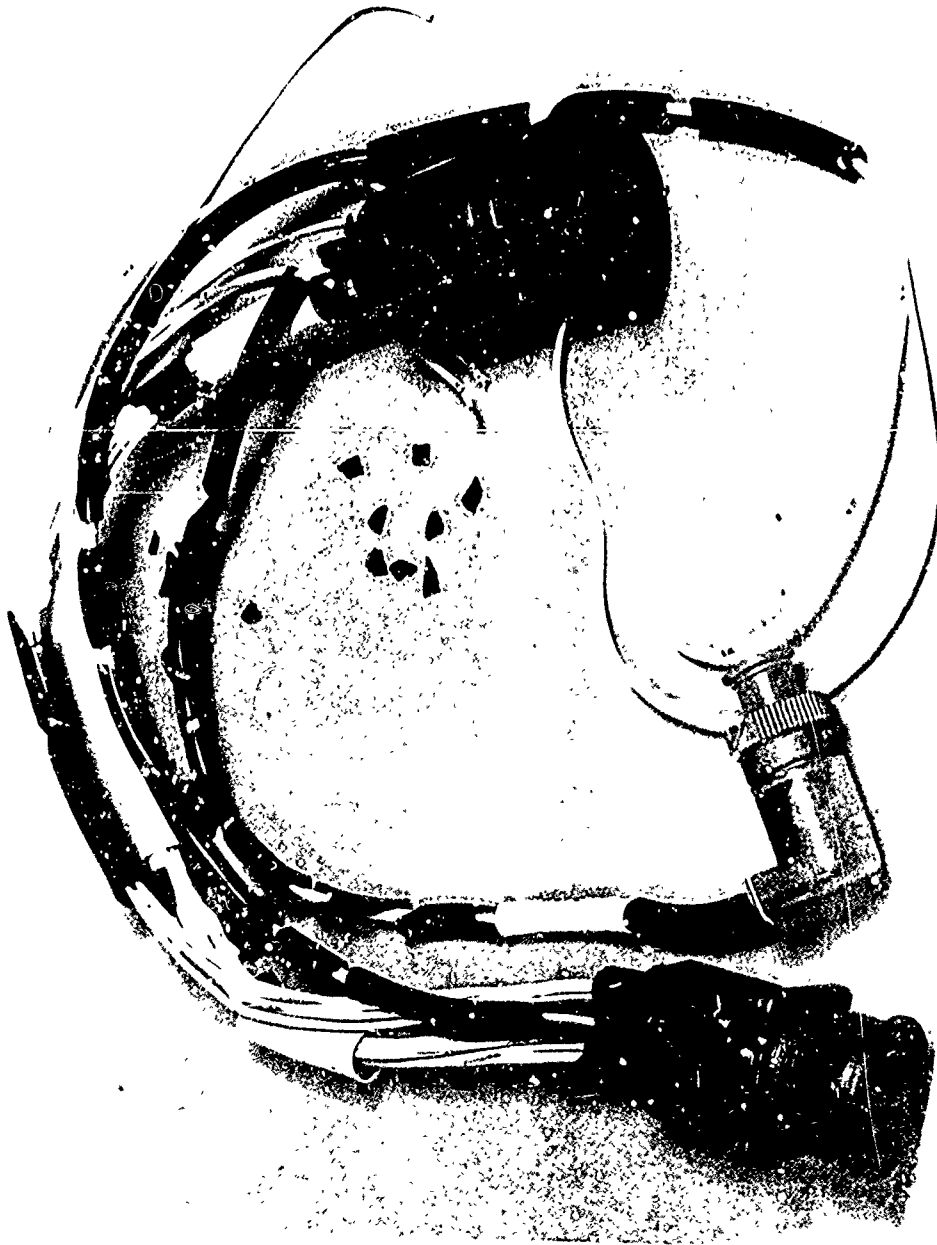
Over All View of an Aircraft Electrical Cables for Weapon Subsystem.
Condition of Cable from Spare Parts Storage (Never Used). PVC Inner
Insulation Generated Acidic Environment Which Embrittled Outer Urethane
Sheathing.

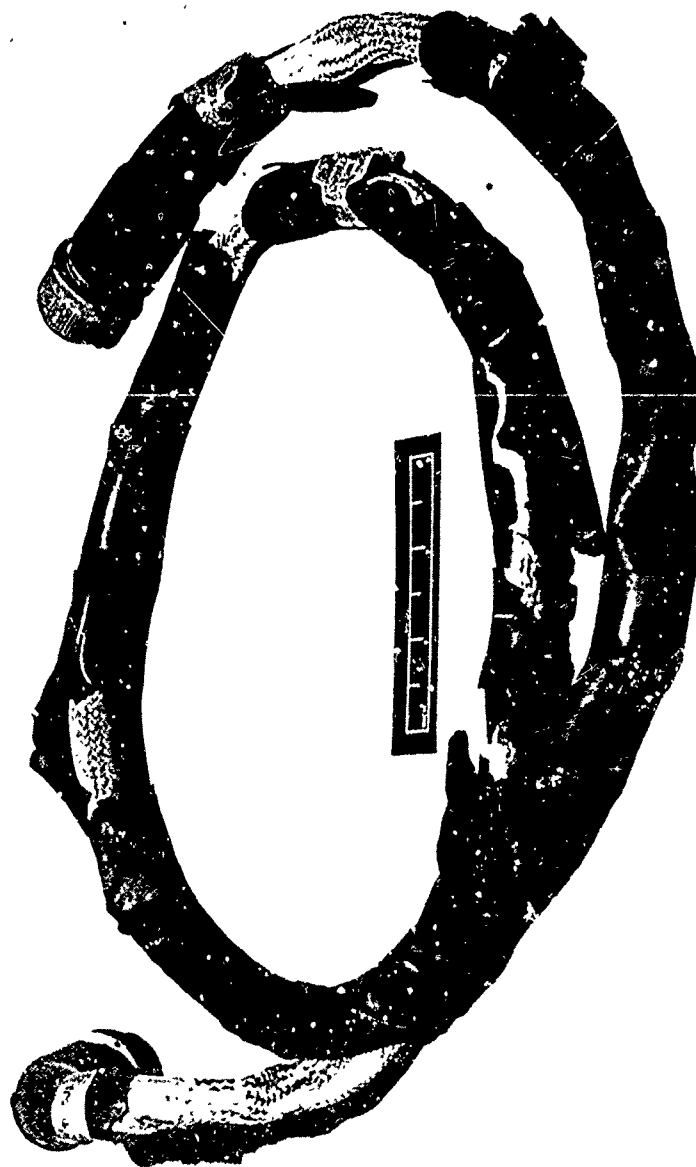
Condition of Electrical Cable from VADS (Vulcan Air Defense System)
Deteriorated Sheathing, Galvanic Corrosion (Green Plaque) and Improper
Wrapping with PVC Tape.

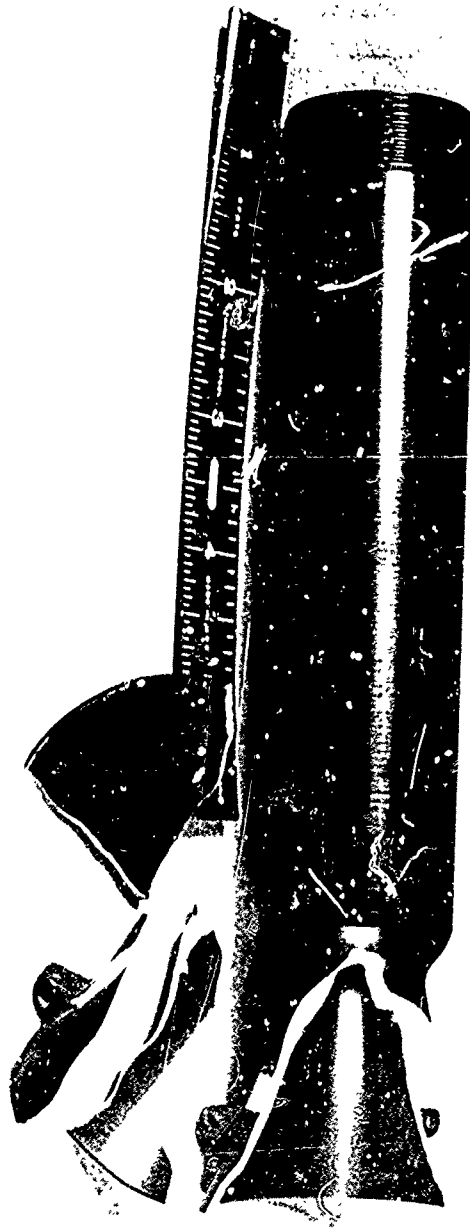
LAW Rocket Motor.

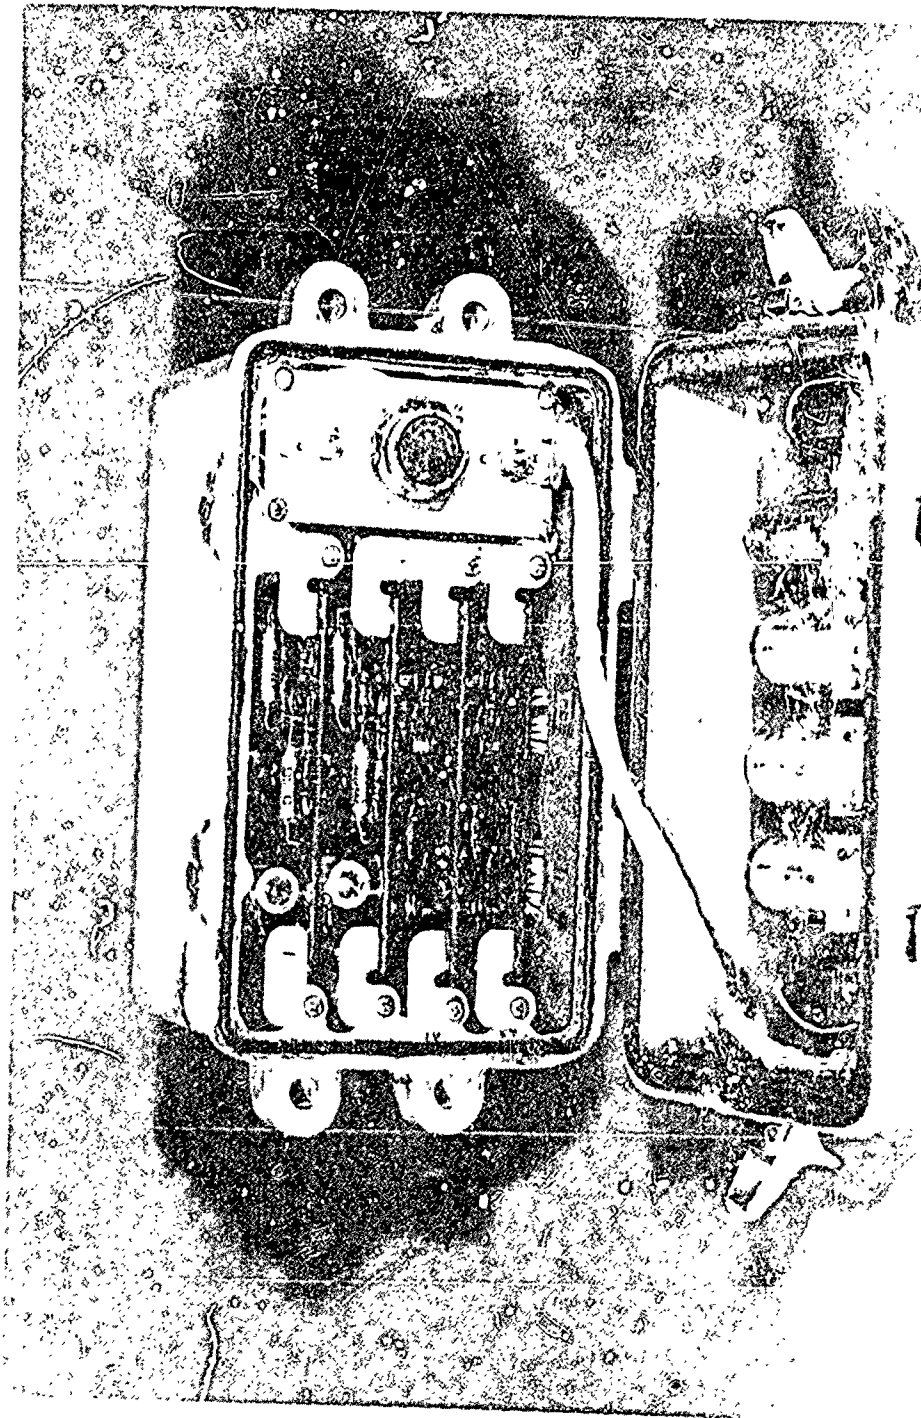
Integrator Amplifier: M551 Sheridan Tank - Note Horizontal Mounting of Circuit
boards

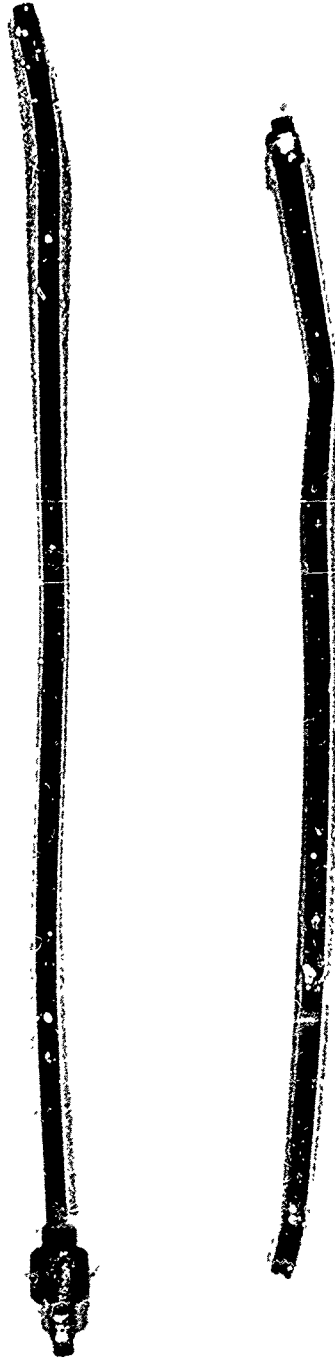
General View of Copper Coated Steel Tubing (Bundy Weld) Used as Fuel Lines
in M113 APC.

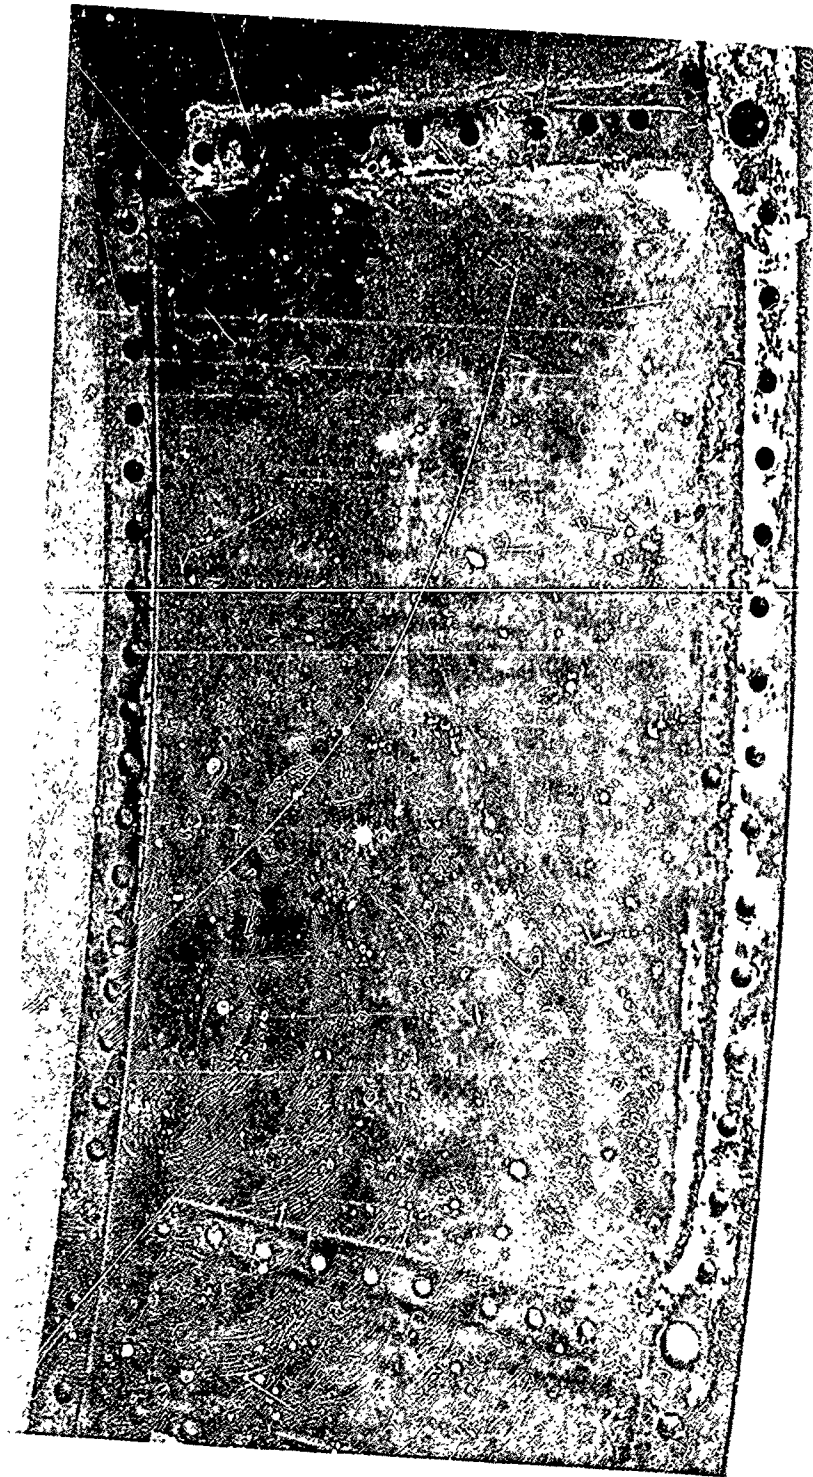
B-52 Engine Cowling Skin - Misplaced Drain Hole Caused Crevice Corrosion in Beach
Mark Areas

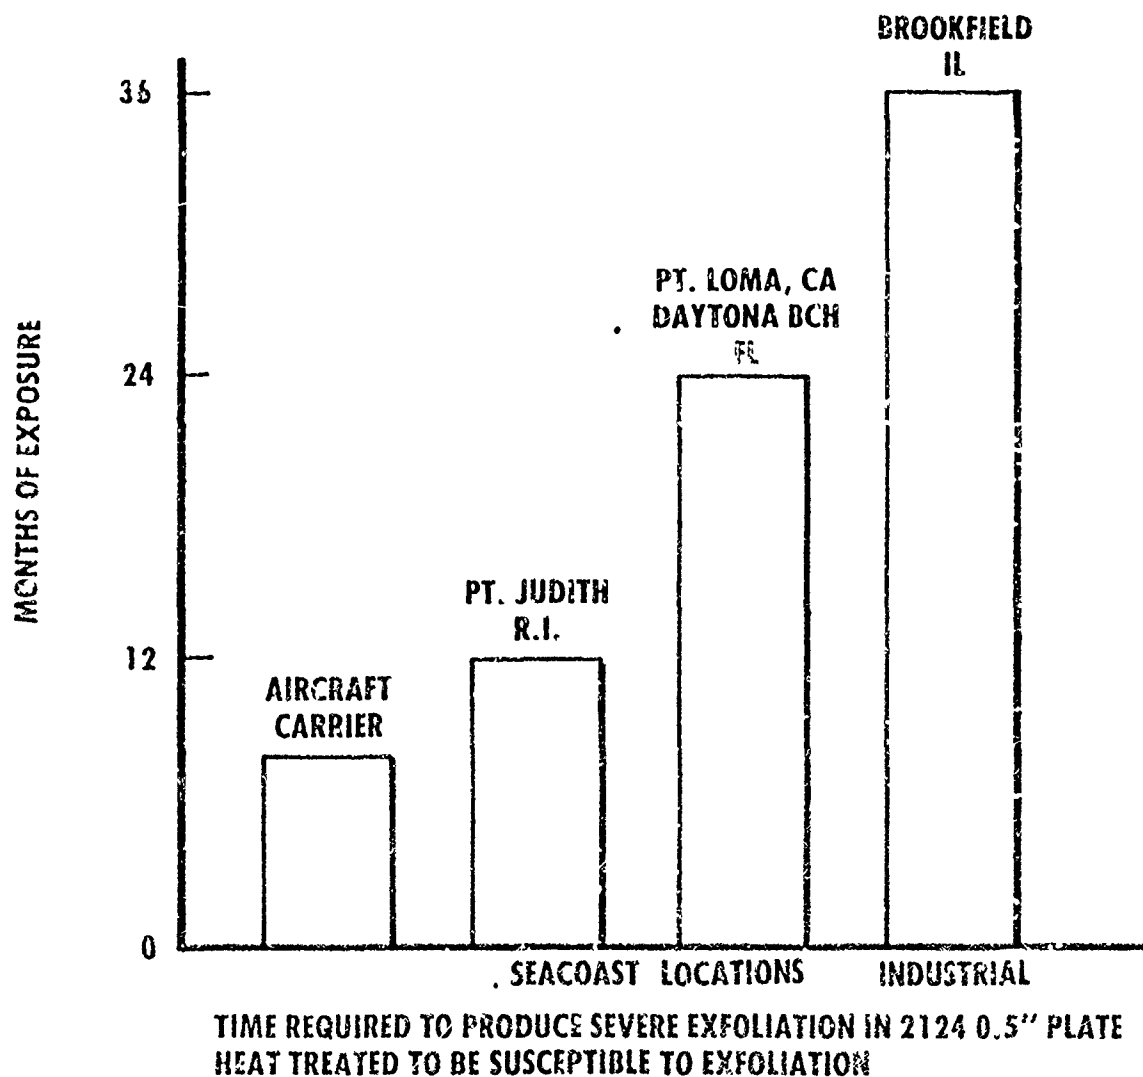
FIGURE 5

COMPARATIVE CORROSIVITY OF ENVIRONMENTS

One striking and important conclusion can be made from these tests. The environment of an aircraft carrier, however powered, is considerably more corrosive than seacoast or industrial environments. This is vividly demonstrated in Figure 5 which is based on data from Sprowls et al.⁴ It took only eight months on a carrier to develop severe exfoliation corrosion on susceptible alloys whereas at the most severe seacoast location (Point Judith, R.I.) it took twelve months and in the most severe industrial location (Brookfield, Illinois) three years. The other conclusion that can be made is that the effect of climate is more significant than presence or absence of sulfur containing stack gases.
